# Manhole Inspection Summary

Manhole # S37KK1001MH

Insp Date: **4/12/07 12:24 PM**

**Location** Address: **4325 YORK RD**

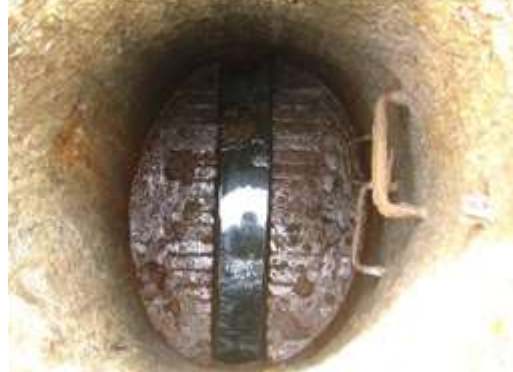
Top View

Barrel infiltration. Corroded and missing steps. Evidence of surcharge - Bench debris. Channel debris.

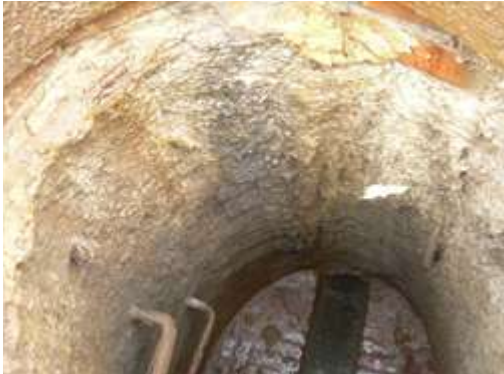
Defect

Frame leaks. Adjustment deterioration and infiltration.

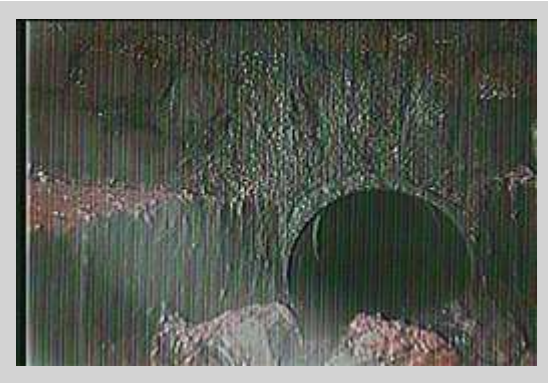
### 8 in. Circular Gravity Sewer Pipe Out @ 12 O'Clock

Barrel deterioration and infiltration.

Deposits: ☐ None ☒ **Mud** ☐ Sludge ☒ **Debris** ☐ Grease

Silt Depth: **1** (in.) Deposits Extent: **Light**

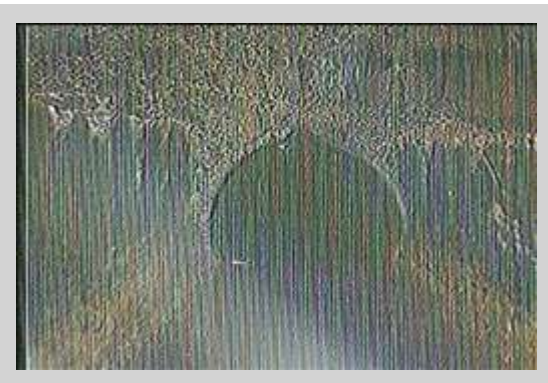
### 8 in. Circular Gravity Sewer Pipe In @ 6 O'Clock

Deposits: ☐ None ☒ **Mud** ☐ Sludge ☒ **Debris** ☐ Grease

Silt Depth: **1** (in.) Deposits Extent: **Light**

Infiltration: **None** Pipe Seal Cond: **Broken**
